Old St Oswald's Church, Fulford

Interim Report for CBA & Church Commissioners 1980

St Oswald, Fulford, York

Philip Raby and Lorna Wallis

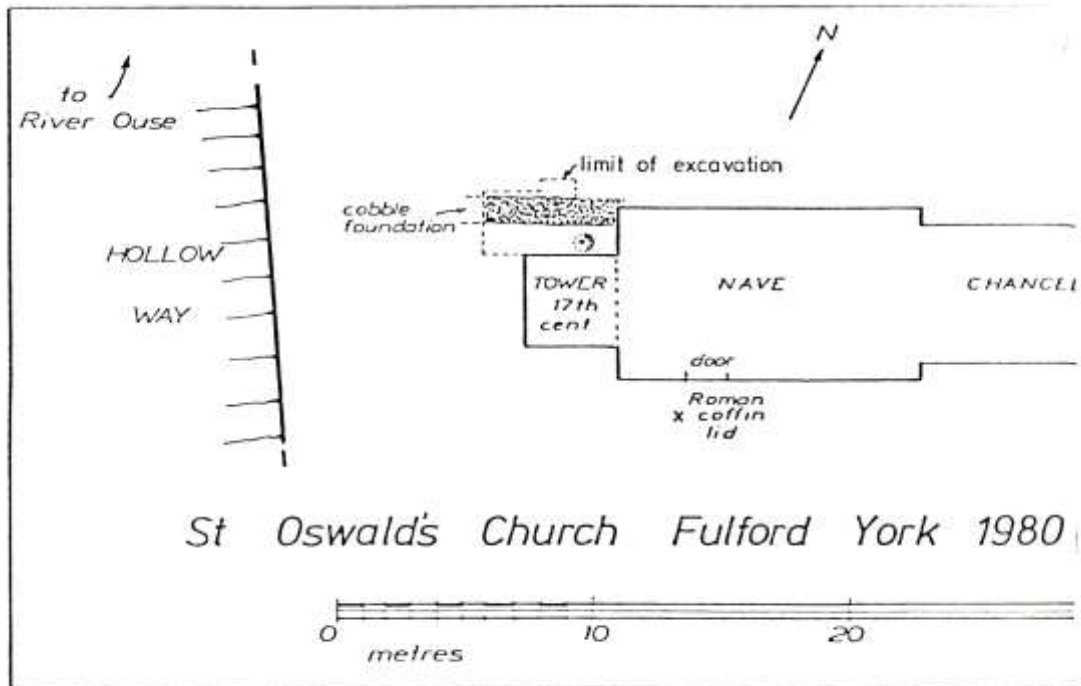
Fig 3

A JCB trench was dug for water, gas, and telephone along the line of the churchyard path from the lychgate to the south door. It was shallow (c 0.5m) and caused minimal damage to underlying archaeology. In the southern part, the brick footings of Wall Cottage and some floor levels were recorded but the soil beneath them appeared sterile.

None of the post-1870 graves in this area extended into the trench but in the area of the older churchyard the trench encountered continuous 'grave-earth'. Some skeletons were skimmed at the very base of the trench and bones disturbed from earlier graves were present in all levels.

About 2m south of the south doorway, the keeled lid of a Roman coffin was hit by the JCB and partly displaced. It had been lying (upside down) across the trench on an E-W orientation. It probably marks the position of a medieval or later grave. Its origin is a matter of speculation but its size and weight may suggest that the coffin to which it belonged is not far distant from the church, if not on its site, and was perhaps discovered during foundation or grave digging. A Roman burial ground here provides one model for the location of the church.
