WELL HOUSE, FORMALLY ADJACENT TO THE OLD CHURCH OF ST. OSWALD, FULFORD.

AN INVESTIGATION OF THE EVIDENCE, WITH ADDITIONAL REFERENCE TO THE TOWER AND SPIRE BY ALLAN FRANCIS

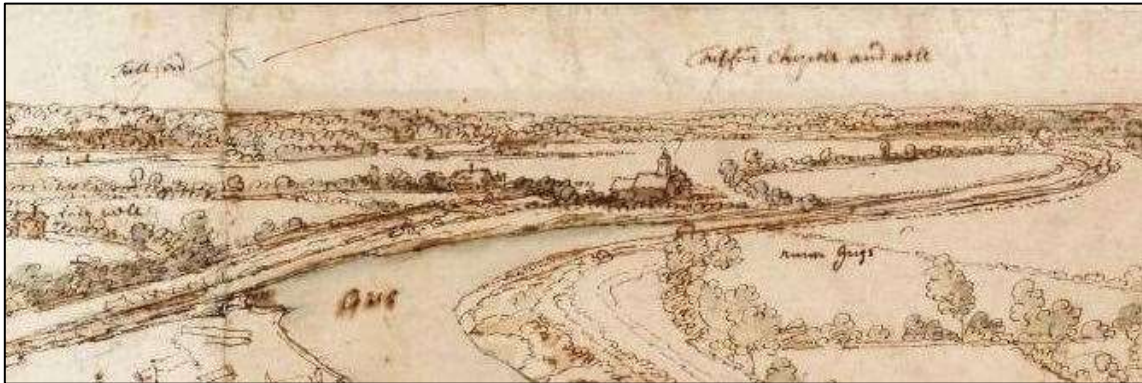
Francis Place: Panoramic view looking south from Clifford's Tower. 1705

The earliest image that is known of St. Oswald's chapel and Well House is the Francis Place panoramic view 1705, looking south from Clifford's Tower (shown above). It is probable that the image was created using the camera obscura, a process of projecting an image through a small hole in a card (basic method), onto a surface in darkened room/area, from where the inverted image is traced onto paper. This technique was popular from the second half of the C16th as an aid for creating accurate drawings/paintings. This would explain the detail shown in the far distance of this panoramic view. Miraculously, in the distance can be seen St. Oswald's and buildings peeping out from behind. On close analysis, the building to the west of the Well House group is much as it later appears in the 19thC plan, however, towering above all the other buildings, is the separate building to the south.

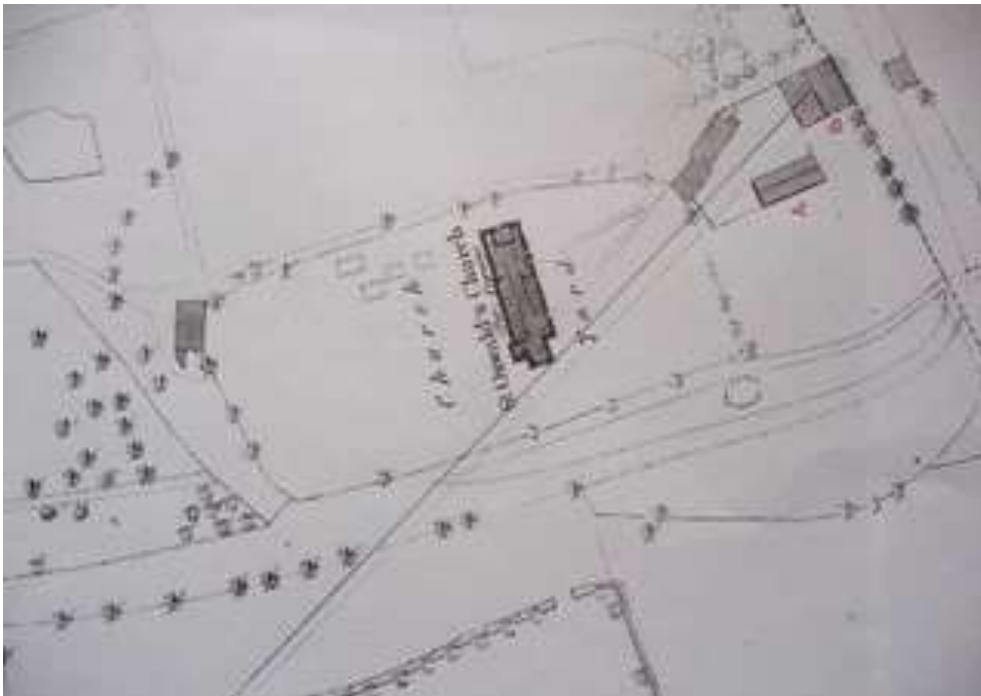
Image 1

This is a mid C19th plan showing the Church and buildings. Superimposed is the sight line and field of vision of Nicholson as he recorded the church. Beyond the church can be seen the whole of building A and part of the roof of building B.

In the Nicholson drawing of 1820's, which is also from the north west and surprisingly, almost at the same angle, can be seen part of the group of these buildings. The building to the west of the group, again, is largely unchanged, but the building to the south is much reduced in height and the roof can be just glimpsed through the line of vision. (See the plan showing Nicholson's viewpoint from where he was standing).

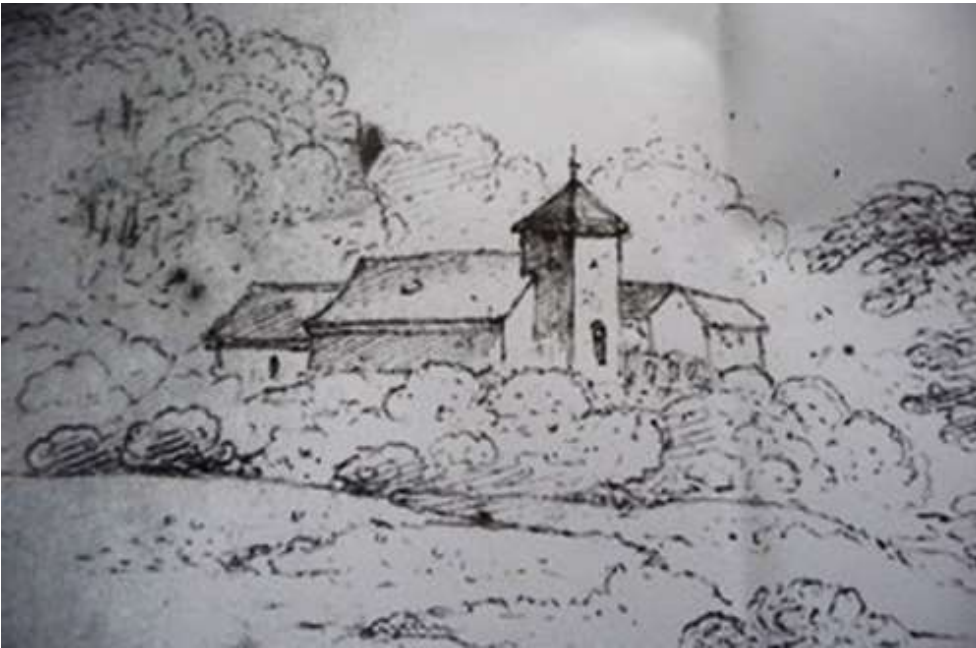
Image 2

This is the Nicholson drawing. He may have been standing on the east bank of the river, with the ings in partial flood, hence the reflected image on the water, or he may have been on the west bank looking across. The ground falls away to the south of the church; consequently, the Well House group of buildings are on a lower level. Judging by the relative height of the building visible, to the church, it would appear to be of two stories. The section of roof between this building and the church is actually the roof of the substantial building, the south wall of which would have been where the current south boundary wall is with St. Oswald's road, to the east of the lychgate.

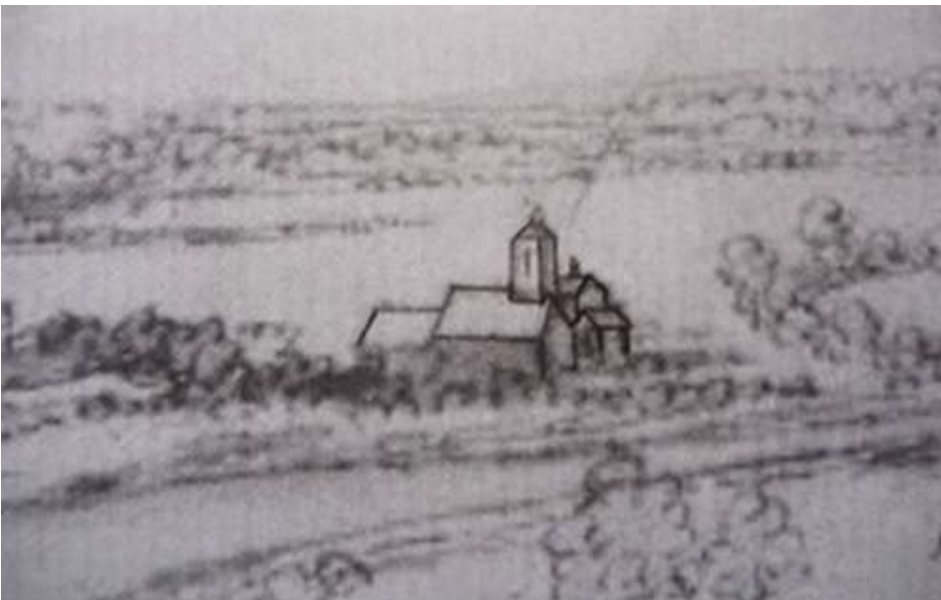
Image 3

This is the Francis Place drawing of 1705. Although this drawing observed from approximately 1 mile from the church it shows a remarkably clear image of the church and Well house. When the digital image is enlarged, surprising information becomes apparent. A closer examination of the original, I am sure would confirm what can be deduced from this image.

Regarding Well House, when the information from the map and the drawing of Nicholson are considered, the gable-ended house nearest the church would appear to be much as it was 120 years later, however, the building to the south is seen towering above the church. This building was on a much lower level to the church and therefore would have been of considerable height. By the 1820's the roof height has been significantly lowered.

There is no evidence of a tower in the Place drawing but the steeple is clearly visible. Prof. Eric Gee in his survey stated that the foundations of the tower dated from C14th therefore it can reasonably assumed that at sometime after this date but no later than 1577, the tower was removed and replaced by a steeple, built into the roof of the nave. C1795 the brick tower was built on the old stone foundations, but surprisingly, there is no record of the removal of the steeple and the building of the new tower, even though this would have been a significant expense.

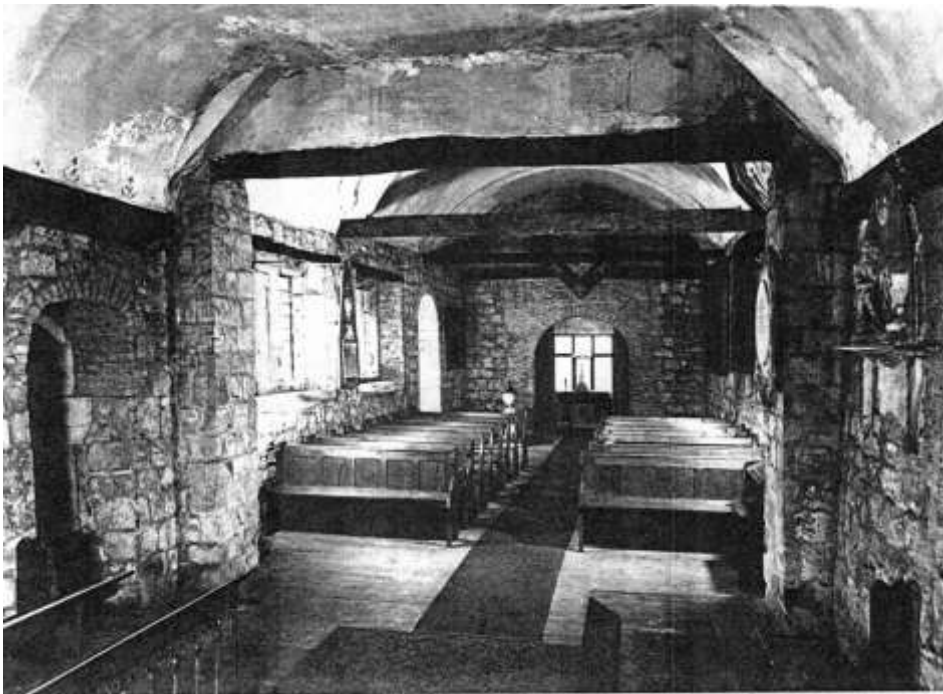
Image 4

This photograph is looking from the Chancel through the nave towards the tower and shows the roof and cross-timbers. It was taken in the 1960s, when the church was still in use as a mortuary chapel.

The work carried out in the early part of the C19th gives a clue as to what may have been roof work following the removal of the “steeple”. The joist slots of a substantial crossbeam at eave height indicate that the steeple may have been 12’ square and located at the west end of the nave. It would only have been possible to have built a gallery, as happened at this time, once the steeple was removed. Removal of the steeple would have resulted in a gaping hole in the roof and the need for major repair to the roof structure. The completed rebuild may have looked rather rough; bearing in mind the roof was ancient and already altered to take the steeple. This may explain why the plaster barrel vaulting was carried out.
